SAFETY REPORT - (WH&S + COMMON LAW DUTY OF CARE)

19 October 2016

22 CENTRAL AVENUE, MANLY :: SP7114

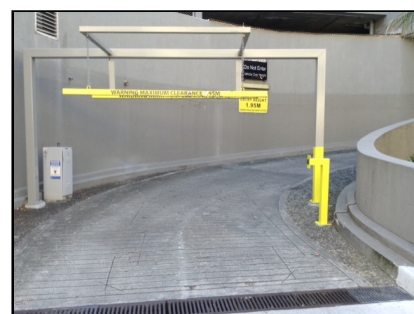
General Location: Entry and exit driveways

1. Line marking is not visible.

Directional line markings have faded which could cause a traffic or pedestrian hazard.

Control measures: In the short term directional line markings should be re-applied regularly. In the long term, put controls in place to prevent the recurrence of the hazard.

Timeframe to rectify: **Short**

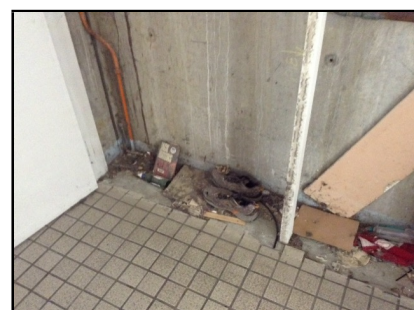
General Location: Ground floor near mail boxes

2. Utility cabinet appears to be not maintained.

Debris is evident in the electrical riser cabinet which may increase the risk of a fire hazard.

Control measures: In the short term ensure regular inspection/maintenance is carried out in the utility cabinet. In the long term, ensure that the subject area or item is properly and regularly maintained and repaired.

Timeframe to rectify: **Short**

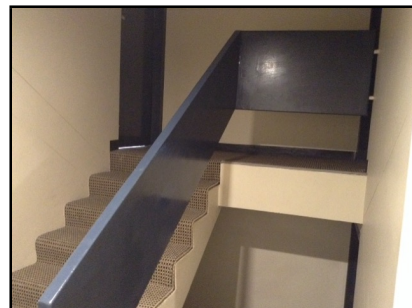
General Location: Internal stairs to the units

3. Balustrade appears to be inadequate.

It would appear that the existing balustrades do not meet the current standards, which may be different than the standards applying at the time of installation causing a potential fall hazard.

Control measures: In the short term if reasonably practicable, the balustrades should be replaced with ones that comply with the current standards. In the long term, ensure that the subject area or item is properly and regularly maintained and repaired.

Timeframe to rectify: **Short**

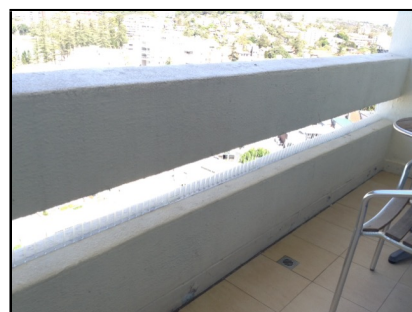
General Location: Balconies

4. Balustrade appears to be inadequate.

It would appear that the existing balustrades do not meet the current standards, which may be different than the standards applying at the time of installation causing a potential fall hazard.

Control measures: In the short term if reasonably practicable, the balustrades should be replaced with ones that comply with the current standards. In the long term, ensure that the subject area or item is properly and regularly maintained and repaired.

Timeframe to rectify: **Short**

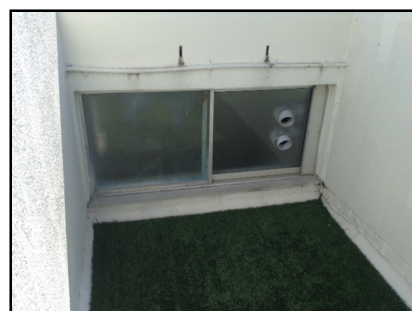
General Location: Laundry windows on the roof top

5. Broken glass is present.

Broken glass in windows was noted on the property which may cause an injury to people.

Control measures: In the short term have a glazier attend the site to replace any windows with broken glass as soon as possible. In the long term, ensure that the subject area or item is properly and regularly maintained and repaired.

Timeframe to rectify: **Short**

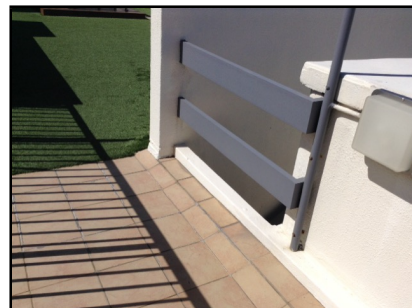
General Location: Roof top stairwell opposite pool

6. Balustrade appears to be inadequate.

It would appear that the existing balustrades do not meet the current standards, which may be different than the standards applying at the time of installation causing a potential fall hazard.

Control measures: In the short term if reasonably practicable, the balustrade should be replaced with one that complies with the current standards. In the long term, ensure that the subject area or item is properly and regularly maintained and repaired.

Timeframe to rectify: **Short**

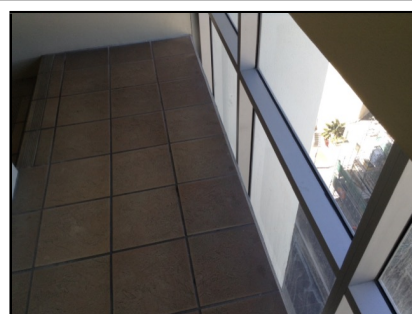
General Location: Stair landing between level 9 and roof top

7. Gaps between the windows and the stair landing are evident.

The gaps between the windows and the stair landing may increase the risk of a fall hazard.

Control measures: In the short term, obtain specialist advice on the most appropriate means to deal with the hazard. In the long term, ensure that the subject area or item is properly and regularly maintained and repaired.

Timeframe to rectify: **Short**

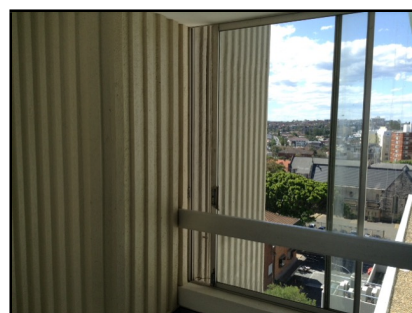
General Location: Level 7 lift lobby

8. Window appears unsafe.

It appears the openable window in the common area is less than 1.7m above the floor which may increase the risk of a fall hazard.

Control measures: In the short term, obtain specialist advice on the most appropriate means to deal with the hazard. In the long term, put a regular inspection regime in place to ensure that the hazard does not recur.

Timeframe to rectify: **Short**

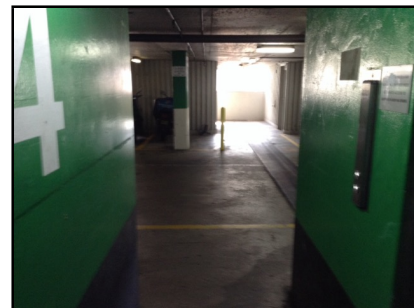
General Location: Car park driveway near the third elevator

9. Low visibility for pedestrians and vehicles.

Obstruction may reduce the visibility for drivers to observe the pedestrians exiting out of the elevator area which may result in a pedestrian hazard.

Control measures: In the short term, obtain specialist advice on the most appropriate means to deal with the hazard. In the long term, ensure that the subject area or item is properly and regularly maintained and repaired.

Timeframe to rectify: **Short**

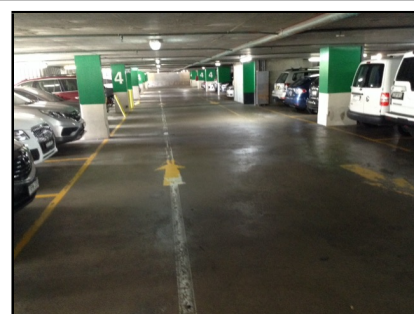
General Location: Car park driveways

10. Speed humps are inadequate.

Speed humps may reduce the risk of vehicular and/or pedestrian hazard.

Control measures: In the short term install new speed humps in the appropriate critical areas. In the long term, ensure that the subject area or item is properly and regularly maintained and repaired.

Timeframe to rectify: **Short**

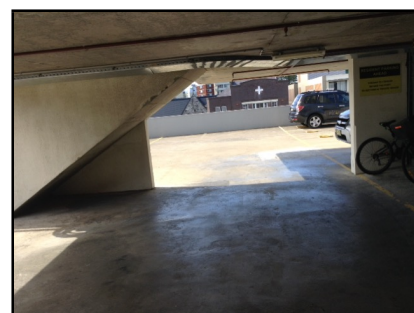
General Location: Near private car spaces 935 & 934

11. Inadequate signage for low clearance.

It appears there is no signage to indicate the low clearance at the entry of the car park which may cause injury to people or damage to vehicles.

Control measures: In the short term the low clearance hazard can be either clearly marked, isolated by way of barriers, removed, or protection provided to the likely strike area(s) as one of many possible solutions. In the long term, ensure that the subject area or item is properly and regularly maintained and repaired.

Timeframe to rectify: **Short**

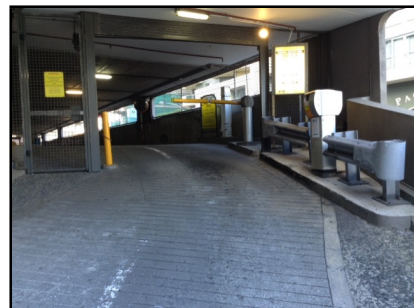
General Location: Driveway/ramp entry to the car park

12. Driveway appears to be unsafe.

The ticket booth placed before the steep and curved driveway at the entry of the car park may increase the risk of a traffic hazard.

Control measures: In the short term, obtain specialist advice on the most appropriate means to deal with the hazard. In the long term, ensure that the subject area or item is properly and regularly maintained and repaired.

Timeframe to rectify: **Short**
